The Athenaeum of Philadelphia Refreshed With Facade Renovation

MARCH 7, 2023 | [by Kimberly Haas](#)

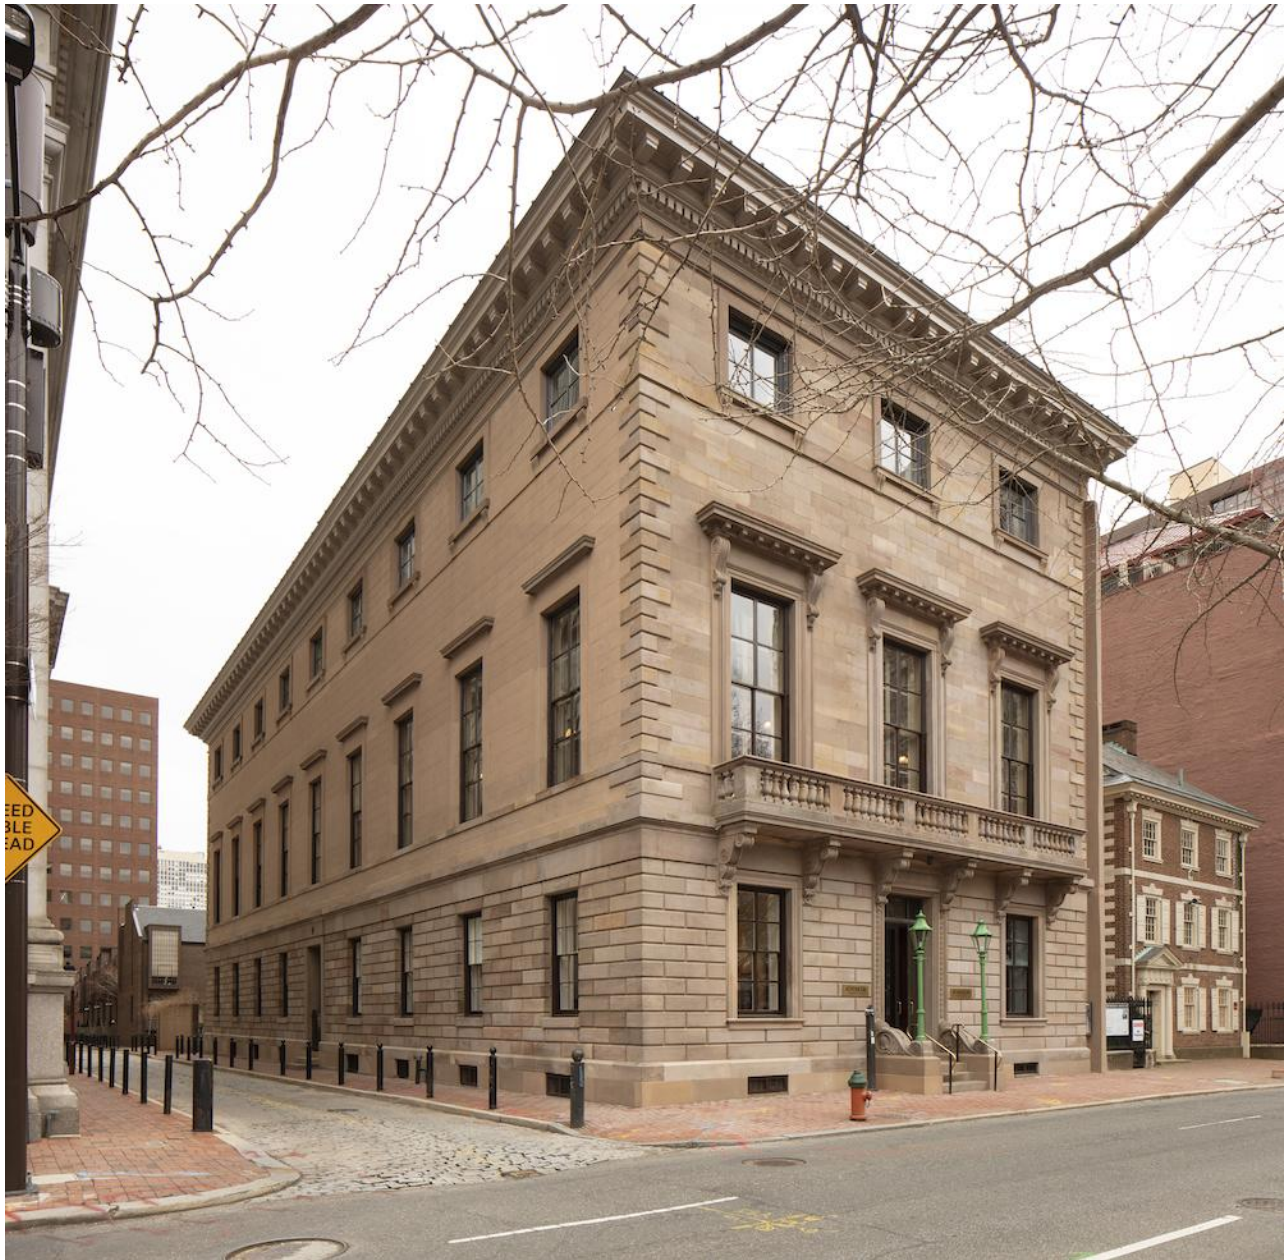
The Athenaeum of Philadelphia at 219 S. 6th Street after recent exterior renovations. | Photo: Joseph E.B. Elliott via The Athenaeum of Philadelphia

A roof replacement in 2021 led to the full renovation of the exterior, a \$1.3 million project to repair deteriorated stone and stucco, restore rotted wooden elements, and clean the facade which was soiled from exposure to pollution and weather. Lighting was added to both highlight the building's architecture and to deter vandals. The front entrance's brass railings were stolen in 2018.

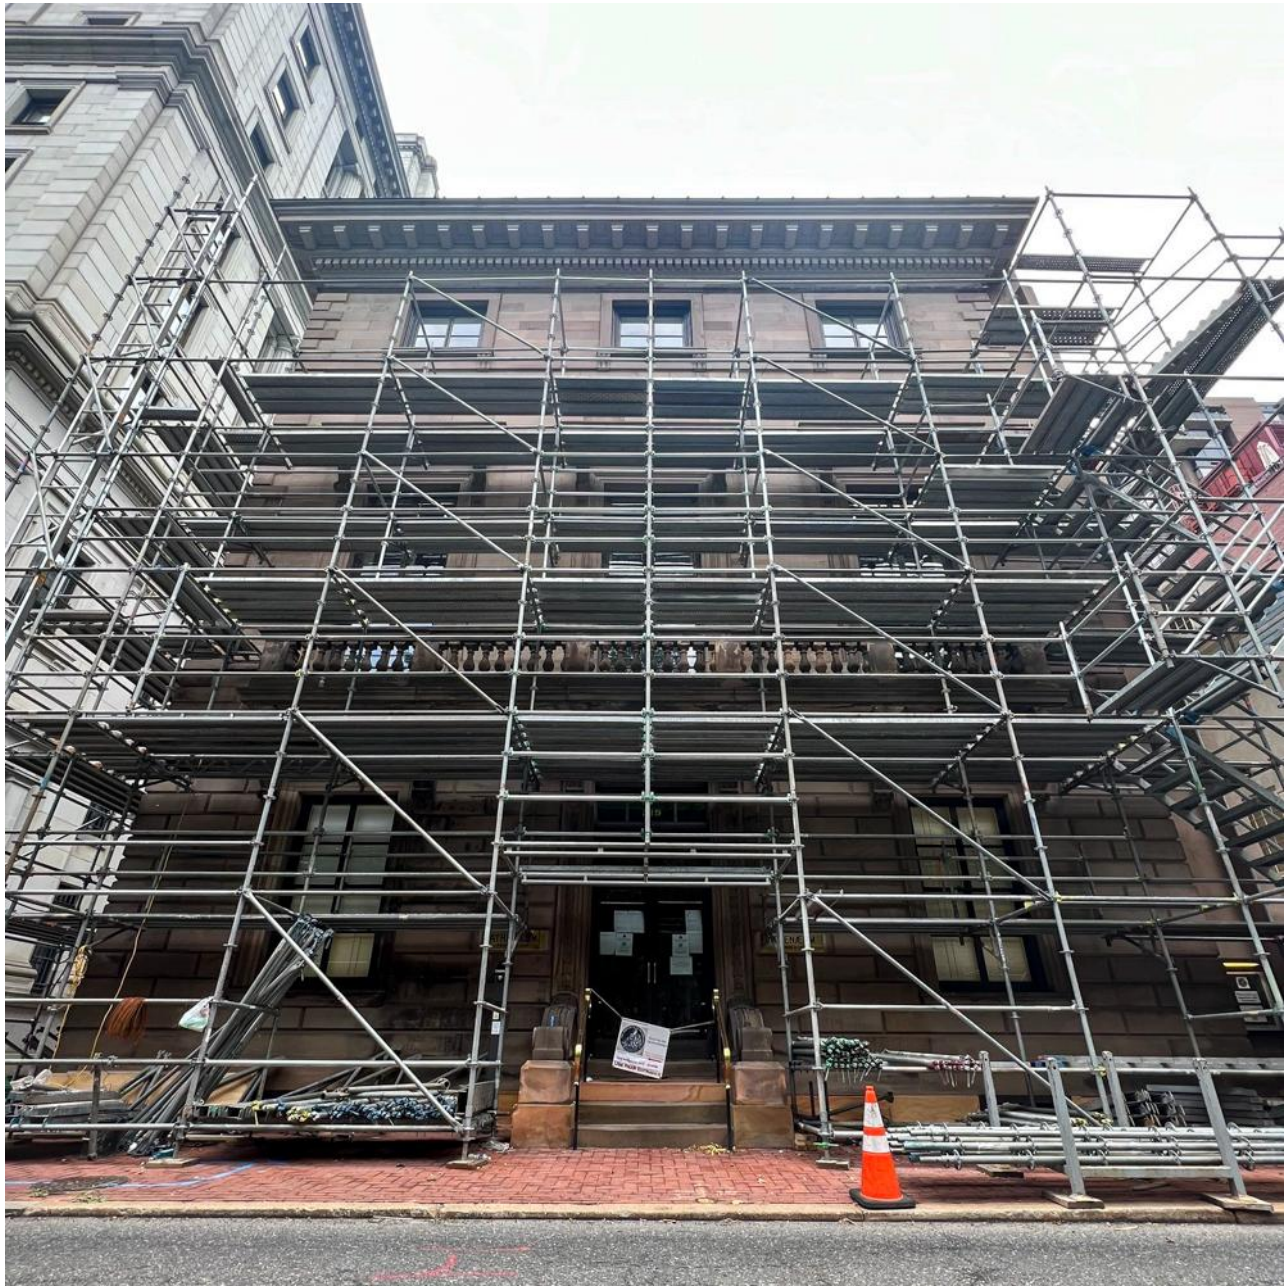
The Athenaeum during facade renovation in 2022. | Photo courtesy of Premier Building Restoration, Inc.

Two of the building's most prominent features, the stone balcony and the wooden cornice, required complete disassembly to repair. "We

reassembled the front balcony, which had suffered a lot of damage,” said Yoder. “It has a lot of detail, which increases the surface area and exposes it to more damage.”

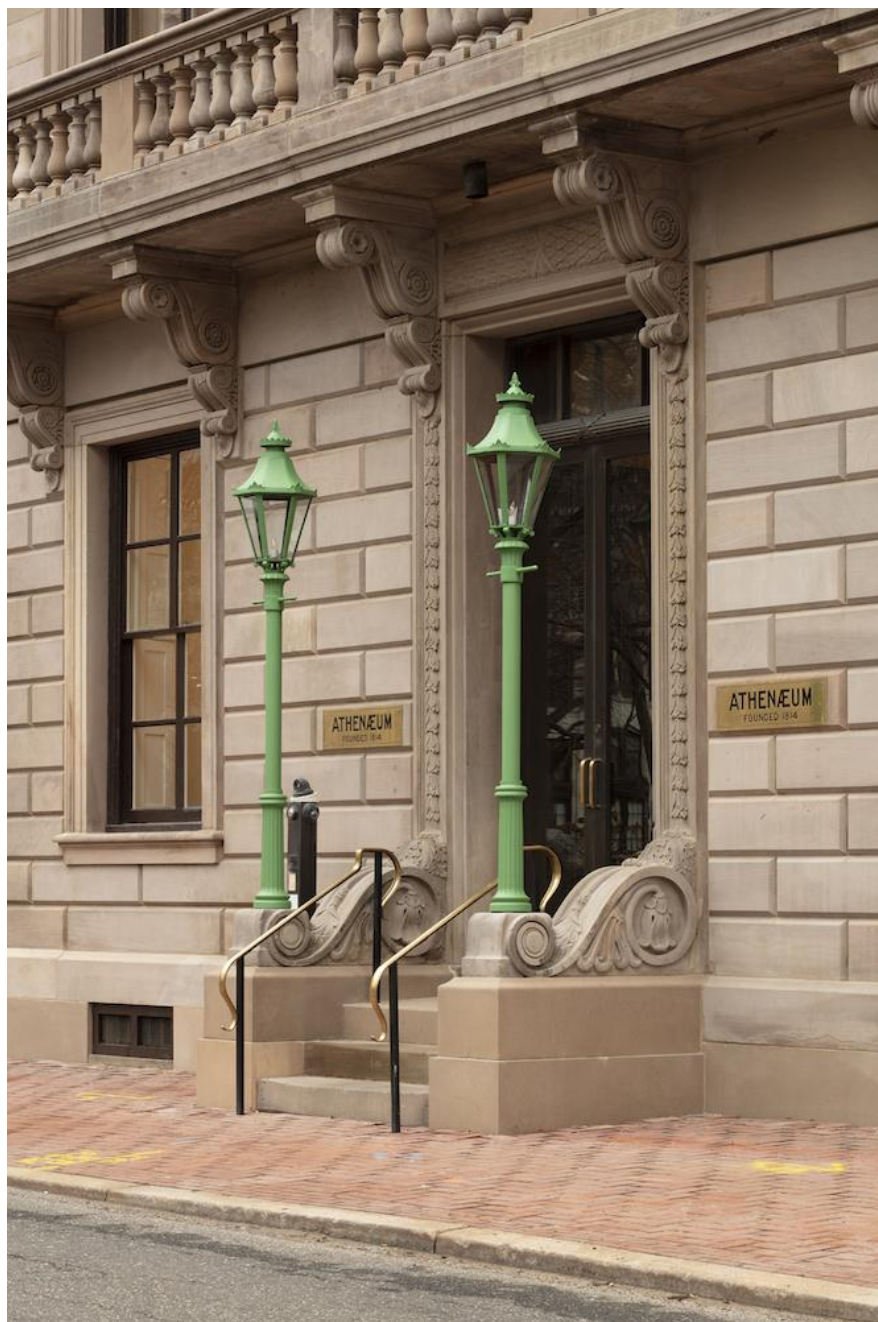
The Athenaeum's west entrance after exterior renovations. | Photo: Photo: Joseph E.B. Elliott via The Athenaeum of Philadelphia

“As the facade became clear, the choices and placements of individual stones became obvious,” noted Christina Doe, the Athenaeum’s building supervisor. “All of these patterns and striations became visible,” agreed Hessel. “Now you can see the details. It was a stunning building when it was erected. The renovation has brought that back.”

“Patching the brownstone became complex, particularly in trying to match the materials,” said Yoder. “We ended up using about 20 different colors. And it is important to make sure the contemporary materials are compatible with the original materials.” Doe expressed appreciation for the level of detail that went into the work. “It was a bunch of sweaty people bending over stone, saying things like ‘it needs seven percent more yellow.’ The result is that it looks good, so it looks effortless.”

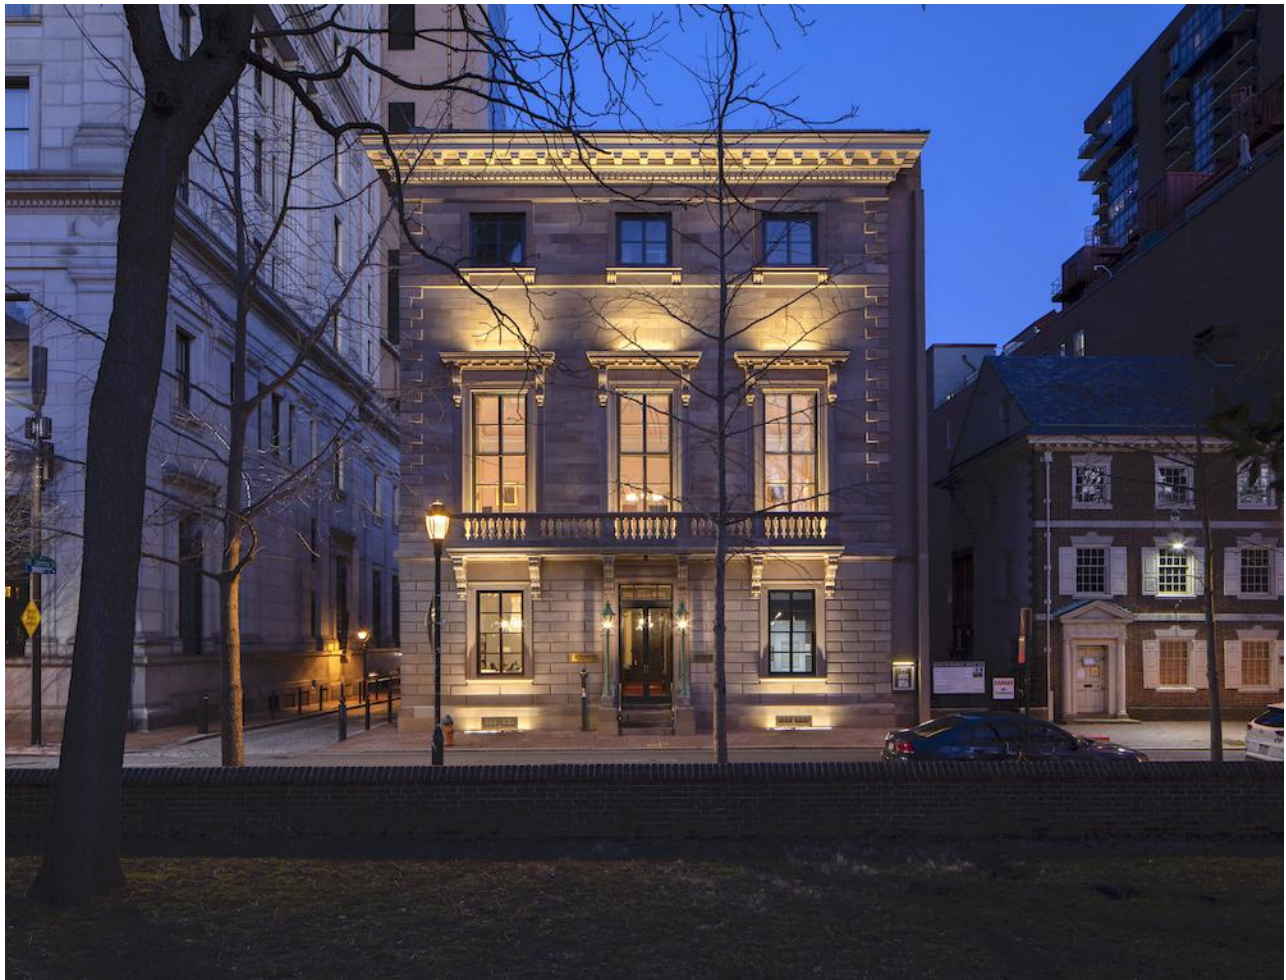
The completed facade renovation at dusk with new exterior lighting. | Photo:
Photo: Joseph E.B. Elliott via The Athenaeum of Philadelphia
